# THERMAL INSPECTION REPORT

Professional thermographic assessment - anonymised client example

21 January 2025

#### Electrical thermography and condition assessment

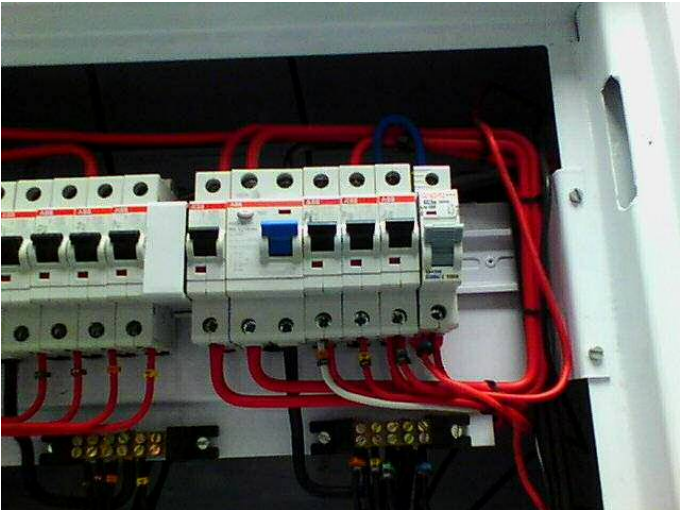
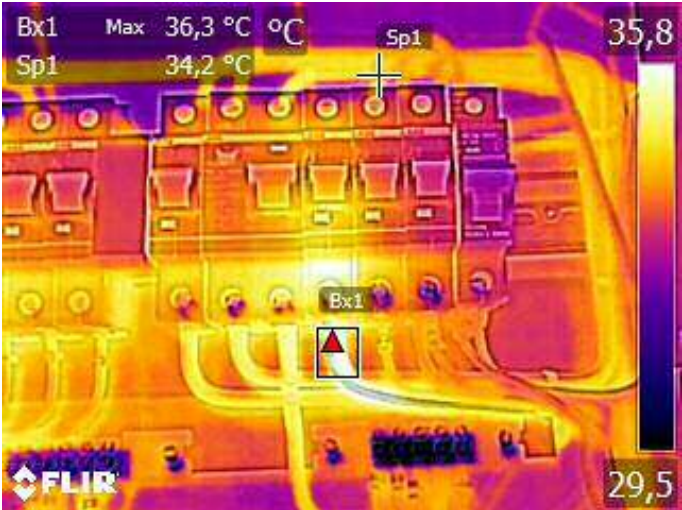
Finding 1 of 3 | Inspection 2025/01/21

| ASSESSMENT | OK - NORMAL | No actionable thermal anomaly |

| 36.3 °C | 34.2 °C | 2.1 °C | OK - NORMAL |

No significant thermal anomaly is indicated in this view. The measured temperature difference is small and is consistent with normal operating variation at the time of inspection.

No corrective action required from this thermal finding. Retain as a baseline image and compare during the next scheduled thermographic inspection.

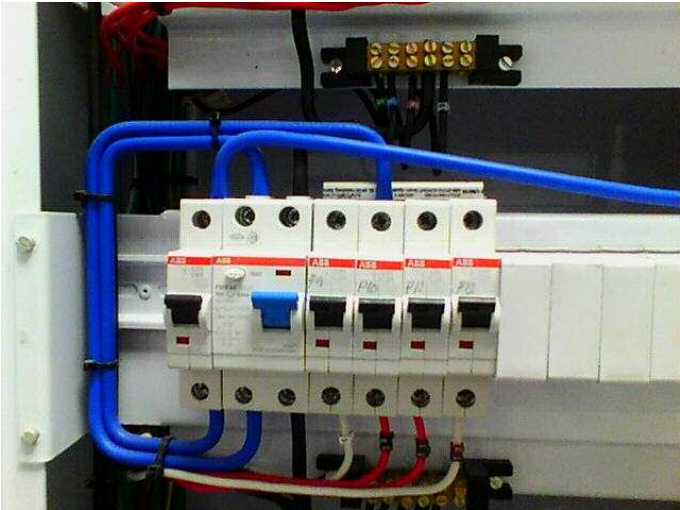
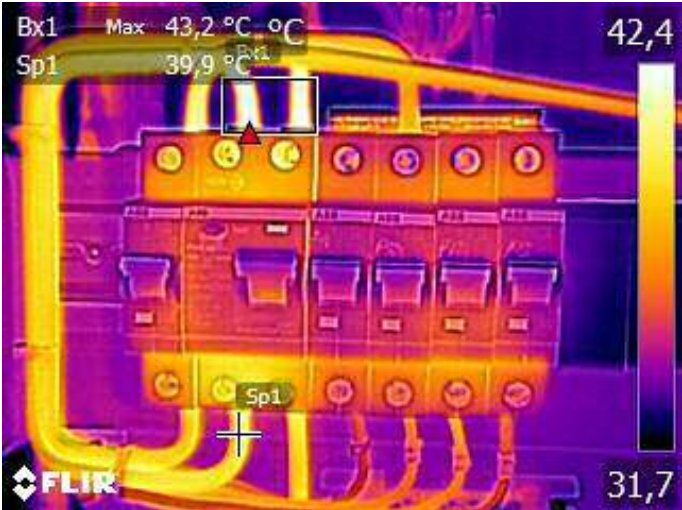
Finding 2 of 3 | Inspection 2025/01/21

| ASSESSMENT | D - LOW / MONITOR | Minor differential - monitor trend |

| TMAX<br>43.2 °C | REFERENCE<br>39.9 °C | $\Delta T$<br>3.3 °C | CLASSIFICATION<br>D - LOW / MONITOR |

A minor temperature differential is present at the upper connection area. The measured  $\Delta T$  is below the report's Category D threshold and does not indicate an immediate repair requirement.

Record this condition as a baseline and compare it at the next assessment. Escalate for investigation if the temperature differential increases, loading changes materially, or visible signs of deterioration are found.

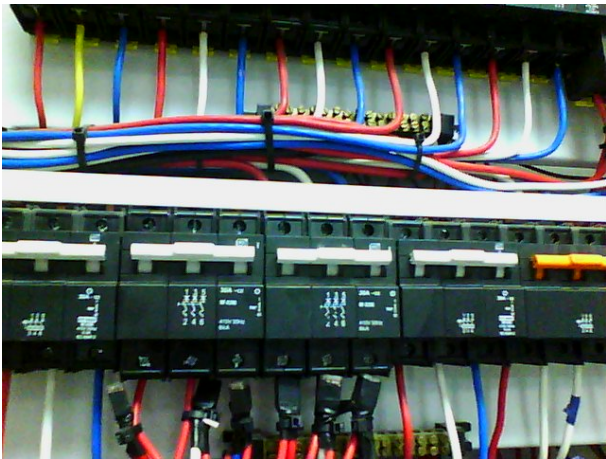
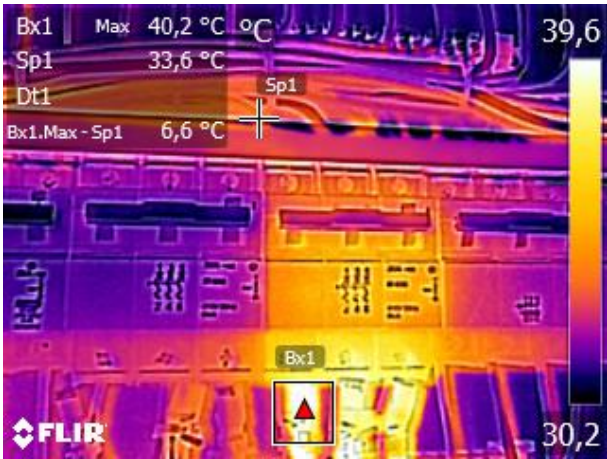
Finding 3 of 3 | Inspection 2025/01/21

| ASSESSMENT | D - LOW / MONITOR | Localized rise - monitor connection |

| 40.2 °C | 33.6 °C | 6.6 °C | D - LOW / MONITOR |

A localized temperature rise is visible at the lower connection area of the distribution board. The thermal image displays a maximum of 40.2 °C and a reference spot of 33.6 °C, giving a Delta T of 6.6 °C. Under the report's severity criteria this remains a low-level condition.

Record and trend this connection at the next thermographic assessment. If the differential increases, or if loading or visual inspection indicates deterioration, arrange an electrical inspection of the affected termination and associated connection integrity.
